THE AERO COMMANDER CHRONICLE

S.J. Swift¹

The service history of the Aero Commander light twins teaches a hard lesson in the theory and practice of fatigue control.

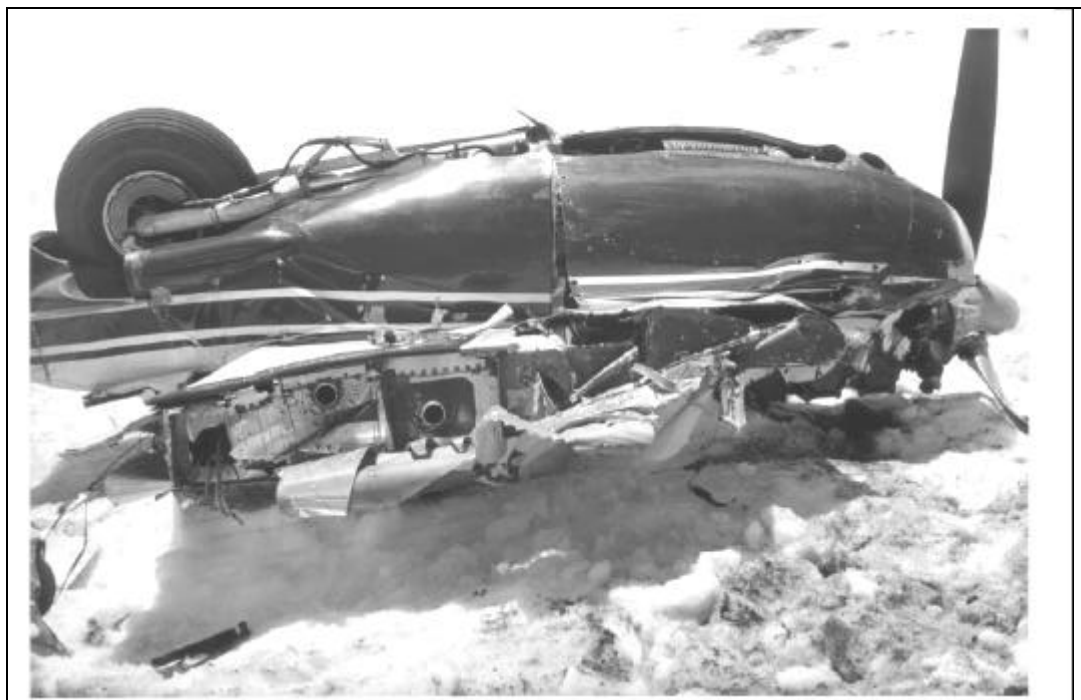
A fatal wing separation in New Zealand in 1961, another in Canada in 1964, and numerous other reported cracks, forced Aero Commander in 1964 to design reinforcing straps for the spar bend. The first were external retrofits, soon added to production. By 1968 the straps were internal and more elegant. The spar caps still cracked, but the cracks grew more slowly to give time for inspections.

Wing separation, New Zealand 1961

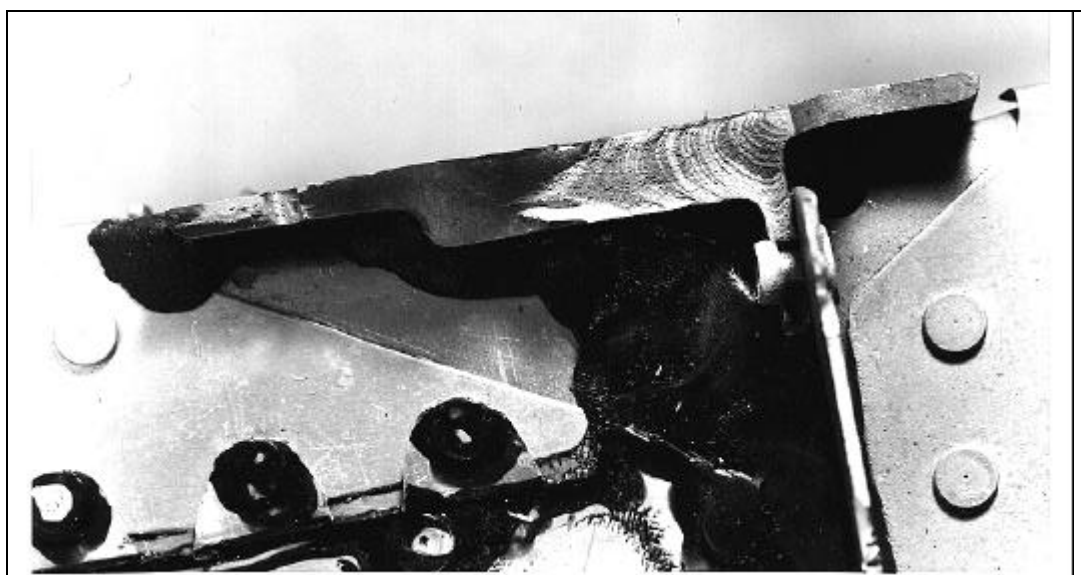
Most of the problems have centred on the bend in the main spar lower cap, where the highest flight stresses coincide with high residual stresses and a geometric discontinuity - at wing station (WS) 24 for short wings and WS 39 for long wings.

Main spar lower cap at Wing Station 24 failure site

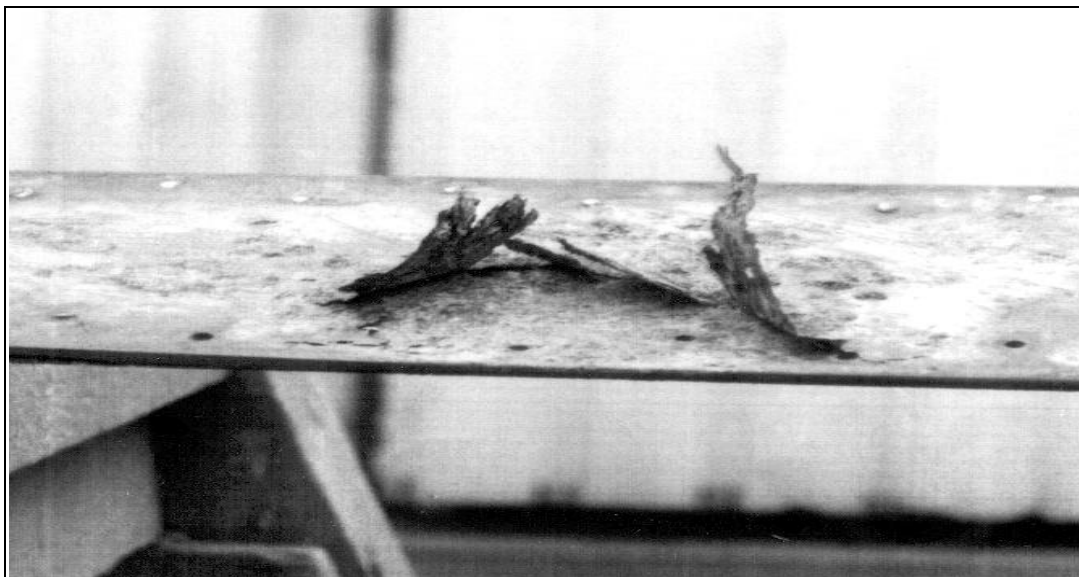
But the straps introduced new problems. The external straps, which only extended fourteen inches outboard of the spar bend, created another fatigue-critical site at the end fasteners. The internal straps were much longer and better for fatigue, but being stainless steel they galvanically corroded the aluminium alloy spar cap.

Exfoliation corrosion in main spar lower cap

Corrosion was first reported in Australia in 1985 and later in the United States. Most Aero Commanders with the stainless steel strap have by now had spar corrosion. Many owners have had to replace the spar cap at great expense. Normally the corrosion has exfoliated, causing a slow loss of spar area. Corroded spar caps have to be inspected more frequently until the corrosion depth exceeds allowable limits.

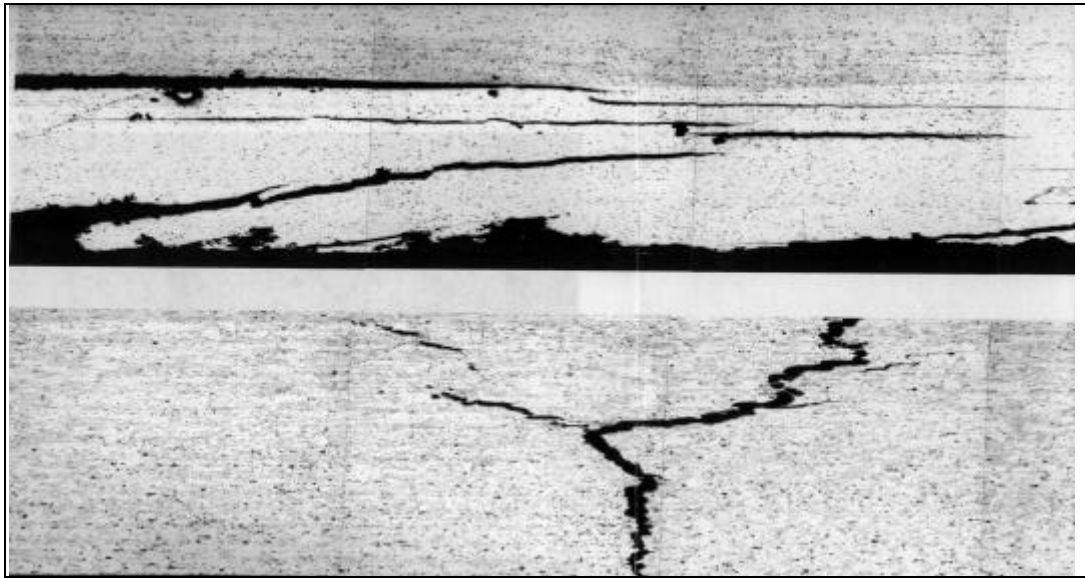
In another twist, in 1991, inspectors looking for corrosion found massive cracks almost right through the spar cap in a couple of aeroplanes. Metallurgical investigation found that the cracks were caused, not by fatigue in this case, but by stress corrosion of a type not normally found in extrusions. The extrusions were faulty in that they had an unusually fine, equi-axed and re-crystallised grain structure. This problem required another set of spar inspections to identify and remove from service all faulty extrusions. A complication was what to do with extrusions which had an intermediate grain structure - there seemed to be little information available to assist those having to make decisions with important safety and financial consequences.

Intergranular corrosion. Upper: exfoliation in a normal extrusion. Lower: stress corrosion in equi-axed grain structure.

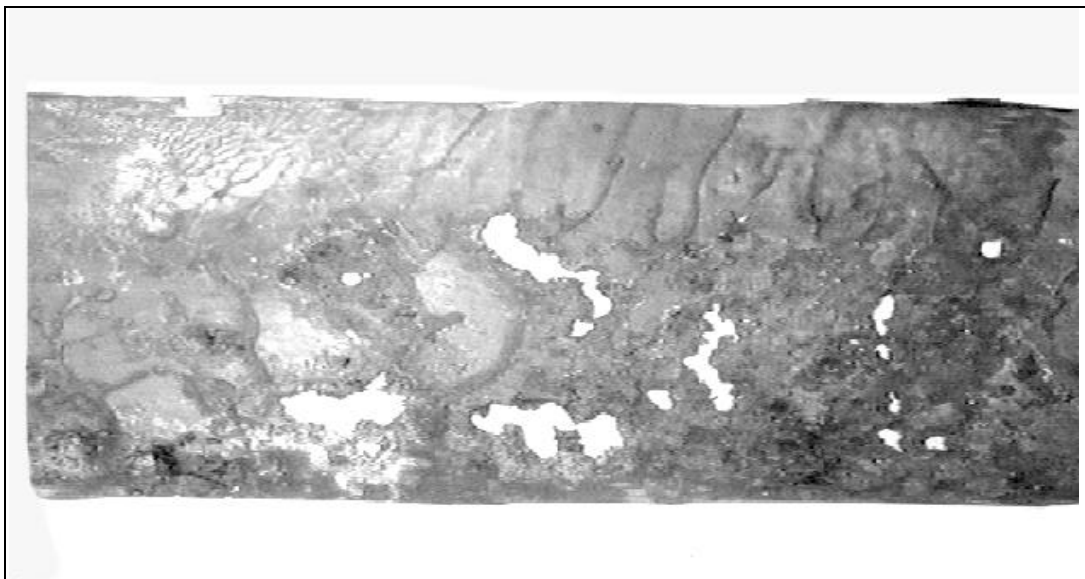
At about the same time another few aeroplanes were found in which the spar caps were intact, but corrosion had eaten large holes in the internal reinforcing straps which were, for some reason, not made from stainless steel. Perhaps there was a supply shortage.

Corroded 4130 steel internal strap

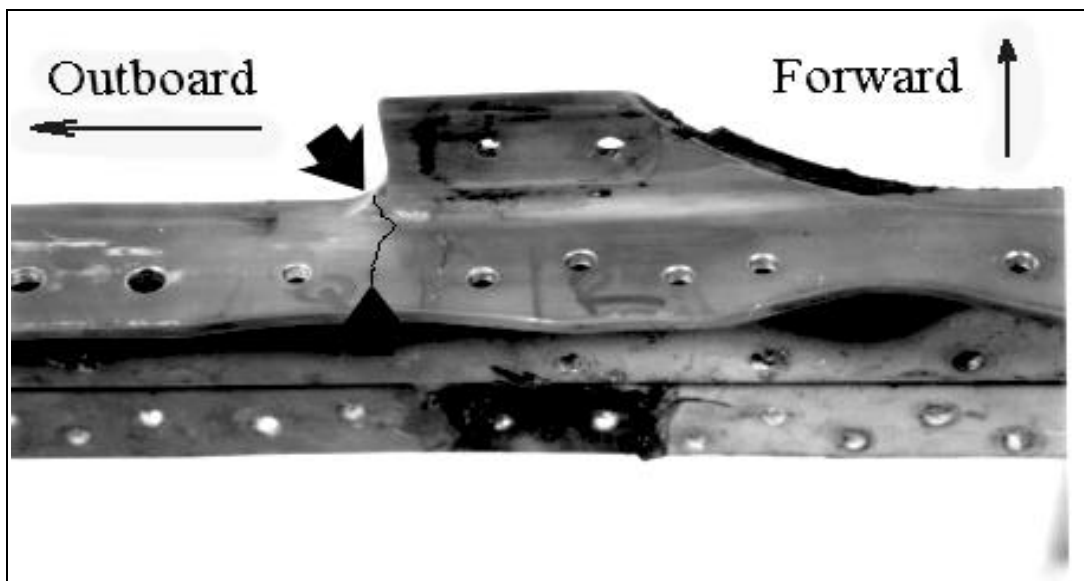
Wing Station 24 - typical crack
